**Flood Control Project Maintenance
Levee Inspections**
LMA District Cover Sheet
Spring 2017 Levee Inspection Results

Reclamation District No. 0817 Carlin

Spring 2017 Levee Inspection Results

Waterway			Bank	Unit Miles
Unit No. 01 South Dry Creek			Left	3.81
	Spring (March - May)	Summer (June - August)	(September - November) Fall	Winter (December - February)
Unit Maintenance Rating (Fall Only)				
Date of Inspection	4/27/2017 - 4/27/2017			
DWR Inspector	Sterling York			
Accompanied By	Joe Conant RD 817

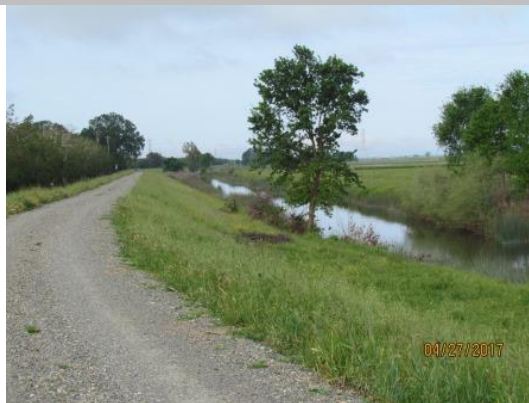
Photo 1 of 1 : SP_2017_RD0817_12_27_20170428_00017.jpg

View looking downstream of the annual vegetation that needs to be maintained, Spring 2017.

LM Start	0.00	Rating **	M	Issue No.	26
LM End	3.81	Issue Type +	Ma	Location *	LS
Category	Earthen Levee			GPS Latitude/Longitude	
				Start	End
Item	Vegetation			38.984700 °	39.019645 °
				-121.506116 °	-121.454091 °
DWR ID	DWR_RD0817_01_s_2017_26				
Comment Code					
V1 : Control annual grass and weeds on the levee slopes and easements.					
Inspector Comment					
Annual vegetation needs to be maintained, Spring 2017.

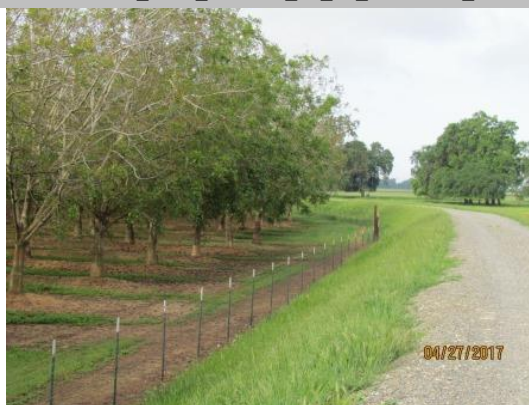
Photo 1 of 1 : SP_2017_RD0817_12_26_20170428_00018.jpg

View looking downstream of the annual vegetation that needs to be maintained, Spring 2017.

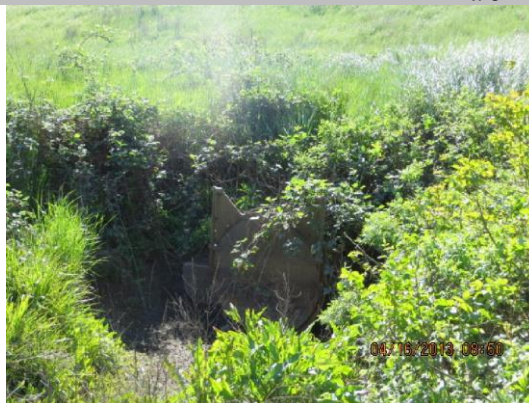
Photo 1 of 3 : UCIP_SP_2017_42685_19865.jpg

LM Start	0.29	Rating **	M	Issue No.	28
LM End	0.29	Issue Type +	Ma	Location *	LS
Category	Supplemental			GPS Latitude/Longitude	
				Start	End
Item	DWR UCIP LMA Responsibility			38.987813 °	38.987813 °
				-121.502963 °	-121.502963 °
DWR ID					
Comment Code					
Inspector Comment					
FS_ID:42685 DS_ID:18985 EP_NO: N/A Repair Type: Non-Urgent Crossing Status: Found UCIP Comments: Dense vegetation on waterward and landward slopes limit visual inspection of potential leaks along pipe alignment. Recommend having owner clear vegetation along slopes. FIELD_STRUCT_DESC: 48-inch corrugated metal drainpipe through levee, 23.3 feet below the crown. Flap gate on waterward end. FS Date: 4/16/2013

WS- pipe, flap gate in dense vegetation on berm

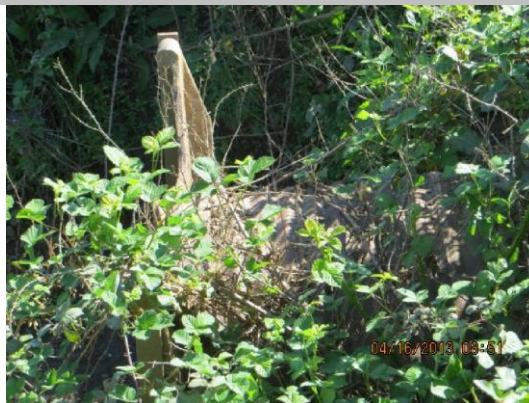
Photo 2 of 3 : UCIP_SP_2017_42685_19864.jpg

WS- CM pipe and flap gate

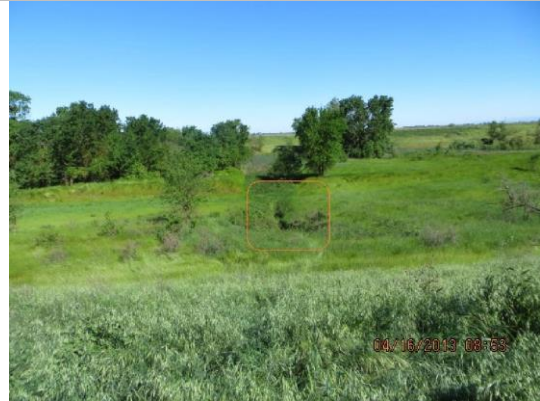
Photo 3 of 3 : UCIP_SP_2017_42685_19863.jpg

LM Start	0.29	Rating **	M	Issue No.	28 (cont)
LM End	0.29	Issue Type +	Ma	Location *	LS
Category	Supplemental			GPS Latitude/Longitude	
				Start	End
Item	DWR UCIP LMA Responsibility			38.987813 °	38.987813 °
				-121.502963 °	-121.502963 °
DWR ID					
Comment Code					
Inspector Comment					
FS_ID:42685 DS_ID:18985 EP_NO: N/A Repair Type: Non-Urgent Crossing Status: Found UCIP Comments: Dense vegetation on waterward and landward slopes limit visual inspection of potential leaks along pipe alignment. Recommend having owner clear vegetation along slopes. FIELD_STRUCT_DESC: 48-inch corrugated metal drainpipe through levee, 23.3 feet below the crown. Flap gate on waterward end. FS Date: 4/16/2013

WS- dense vegetation on WS of the levee

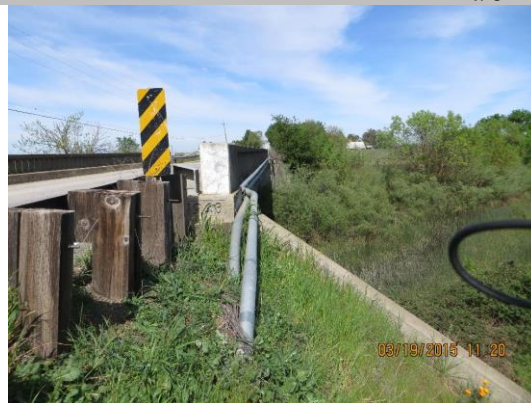
Photo 1 of 2 : UCIP_SP_2017_44084_73565.jpg

LM Start	1.13	Rating **	M	Issue No.	34
LM End	1.13	Issue Type +	En	Location *	LS
Category	Supplemental			GPS Latitude/Longitude	
				Start	End
Item	DWR UCIP Field Study			38.995667 °	38.995667 °
				-121.490981 °	-121.490981 °
DWR ID					
Comment Code					
Inspector Comment					
FS_ID:44084 DS_ID:25088 EP_NO: N/A Repair Type: Non-Urgent Crossing Status: Found UCIP Comments: No permit identified for this crossing. FIELD_STRUCT_DESC: 4-inch steel communication conduit through the levee, 4 feet below levee crown. FS Date: 3/19/2015

Communication conduit visible on upstream side of bridge.

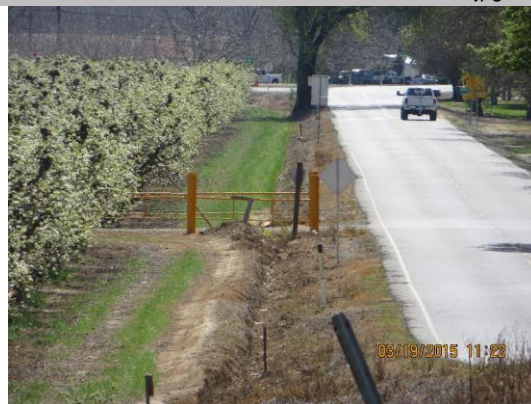
Photo 2 of 2 : UCIP_SP_2017_44084_73564.jpg

Fiberoptic line markers along roadway to south of bridge.

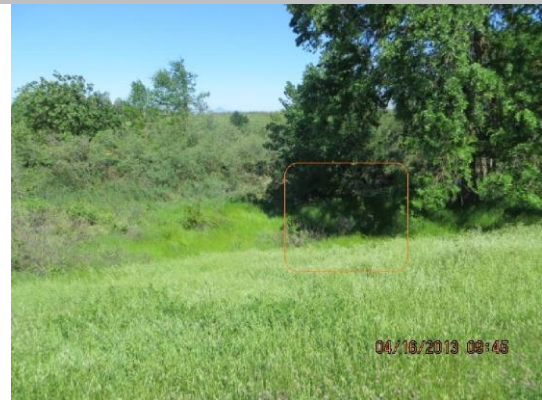
Photo 1 of 3 : UCIP_SP_2017_41153_19882.jpg

Comment Code					
Inspector Comment					
FS_ID:41153 DS_ID:18987 EP_NO: N/A Repair Type: Non-Urgent Crossing Status: Found UCIP Comments: Damaged slide gate on WS of the levee. Need to contact owner to determine status of crossing. If crossing is no longer in use owner will need to contact CVFPB to comply with Title 23. Dense vegetation on waterward and landward slopes limit visual inspection of potential leaks along pipe alignment. Recommend having owner clear vegetation along slopes. FIELD_STRUCT_DESC: *ABANDONED* 18-inch corrugated metal drainpipe through levee, 14.9 feet below the crown. Slide gate on the waterward end. O&M Manual Sac 146, November 1962. FS Date: 4/16/2013

WS- overview of WS area

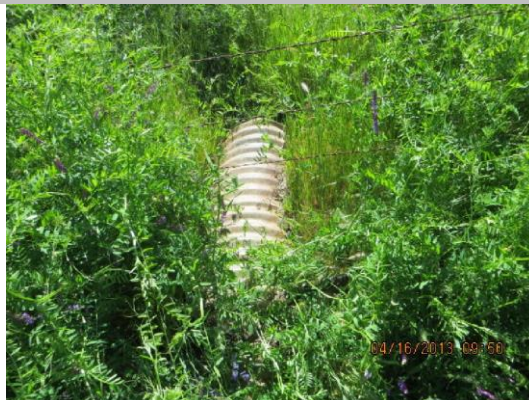
Photo 3 of 3 : UCIP_SP_2017_41153_19884.jpg

LS- CMP on toe of the levee.

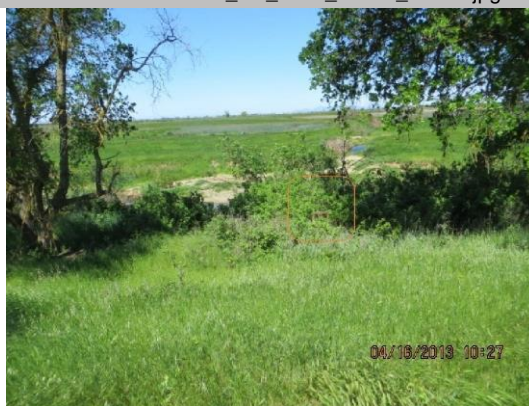
Photo 1 of 3 : UCIP_SP_2017_41157_19892.jpg

FS_ID:41157
DS_ID:18988
EP_NO: N/A
Repair Type: Non-Urgent
Crossing Status: Found
UCIP Comments: A buried slide gate on WS of the levee. Need to contact owner to determine status of crossing. If crossing is no longer in use owner will need to contact CVFPB to comply with Title 23. Dense vegetation on waterward and landward slopes limit visual inspection of potential leaks along pipe alignment. Recommend having owner clear vegetation along slopes.
FIELD_STRUCT_DESC: *ABANDONED* 18-inch corrugated metal drainpipe through the levee, 14.9 feet below the crown. Slide gate on the waterward end. O&M Manual Sac 146, November 1962.
FS Date: 4/16/2013

WS- overview of WS berm

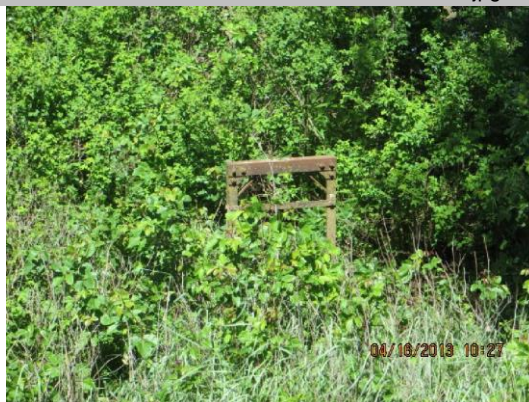
Photo 2 of 3 : UCIP_SP_2017_41157_19891.jpg

WS- slide gate

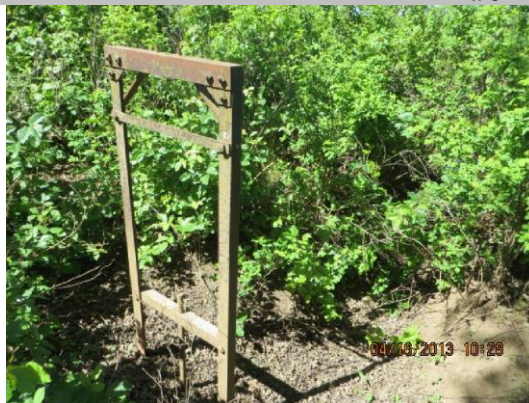
Photo 3 of 3 : UCIP_SP_2017_41157_19890.jpg

Comment Code						
Inspector Comment						
FS_ID:41157 DS_ID:18988 EP_NO: N/A Repair Type: Non-Urgent Crossing Status: Found UCIP Comments: A buried slide gate on WS of the levee. Need to contact owner to determine status of crossing. If crossing is no longer in use owner will need to contact CVFPB to comply with Title 23. Dense vegetation on waterward and landward slopes limit visual inspection of potential leaks along pipe alignment. Recommend having owner clear vegetation along slopes. FIELD_STRUCT_DESC: *ABANDONED* 18-inch corrugated metal drainpipe through the levee, 14.9 feet below the crown. Slide gate on the waterward end. O&M Manual Sac 146, November 1962. FS Date: 4/16/2013

WS- buried slide gate

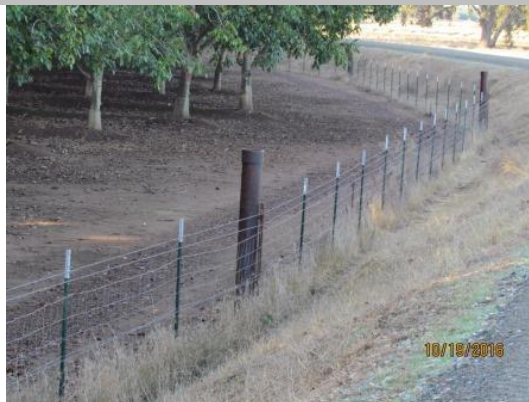
Photo 1 of 1 : SP_2017_RD0817_12_8_20170316_00001.jpg

LM Start	1.74	Rating **	M	Issue No.	8
LM End	3.81	Issue Type +	En	Location *	LS
Category	Earthen Levee			GPS Latitude/Longitude	
				Start	End
Item	Encroachments			39.002941 °	39.019763 °
				-121.484856 °	-121.454151 °
DWR ID	DWR_RD0817_01_s_2013_8				
Comment Code					
FE : Fence					
Inspector Comment					
Wire fence at L/S levee toe.

Wire fence at L/S levee toe. Fall 2016.

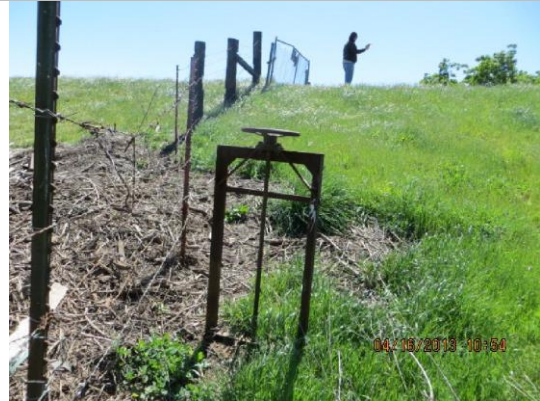
Photo 1 of 1 : UCIP_SP_2017_41156_19895.jpg

Comment Code						
Inspector Comment						
FS_ID:41156						
DS_ID:18989						
EP_NO: N/A						
Repair Type: Non-Urgent						
Crossing Status: Indicator Found						
UCIP Comments: A burried slide gate found on WS. Need to contact owner to determine status of crossing. If crossing is no longer in use owner will need to contact CVFPB to comply with Title 23. Dense vegetation on waterward and landward slopes limit visual inspection of potential leaks along pipe alignment. Recommend having owner clear vegetation along slopes.						
FIELD_STRUCT_DESC: *ABANDONED* 8-inch corrugated metal drainpipe through levee, 11.7 feet below the crown. Slide gate on the waterward end. O&M Manual Sac 146, November 1962. (Permit 16193, 1994, was issued for the removal of this crossing, but slidegate appears to remain on WS toe.						
FS Date: 4/16/2013

WS- slide gate on levee toe.

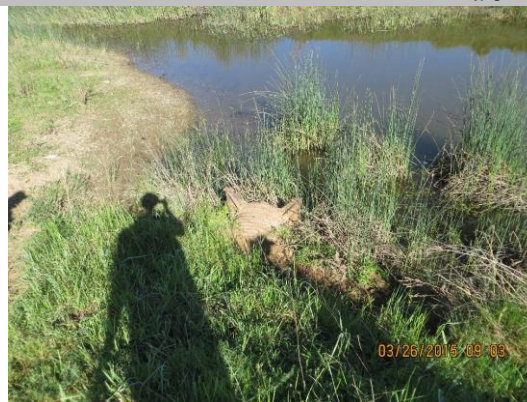
Photo 1 of 3 : UCIP_SP_2017_43946_73422.jpg

Pipe and flapgate visible on WS toe.

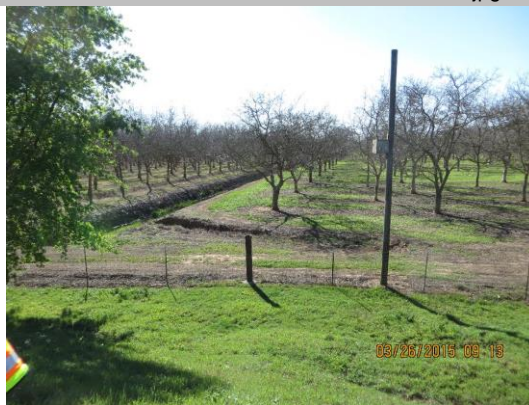
Photo 3 of 3 : UCIP_SP_2017_43946_73420.jpg

LS of pipe buried but alignment would place LS outlet just left of telephone pole on LS toe.

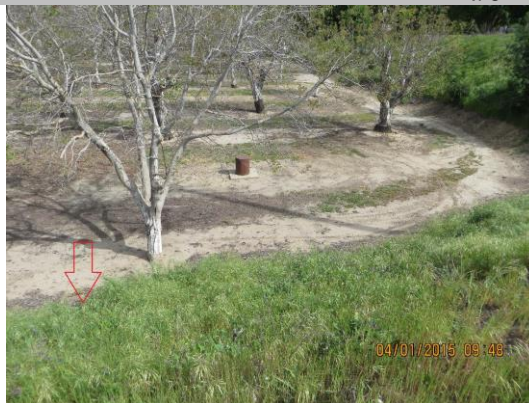
Photo 1 of 3 : UCIP_SP_2017_44064_73542.jpg

Concrete standpipe visible on lower slope of LS toe.

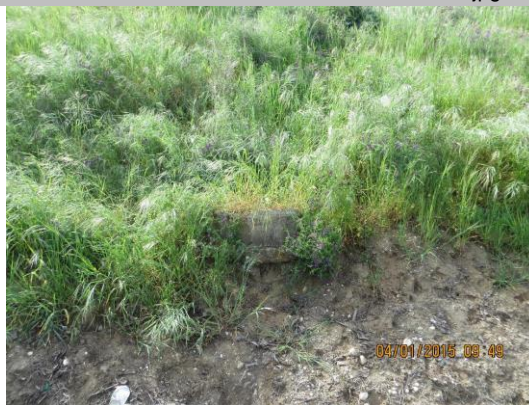
Photo 2 of 3 : UCIP_SP_2017_44064_73541.jpg

Concrete standpipe visible on lower slope of LS toe.

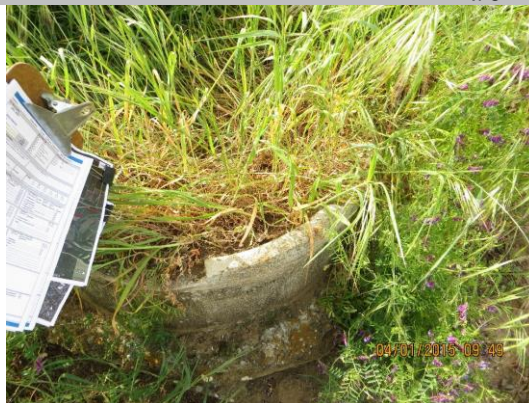
Photo 3 of 3 : UCIP_SP_2017_44064_73540.jpg

Concrete standpipe visible on lower slope of LS toe.

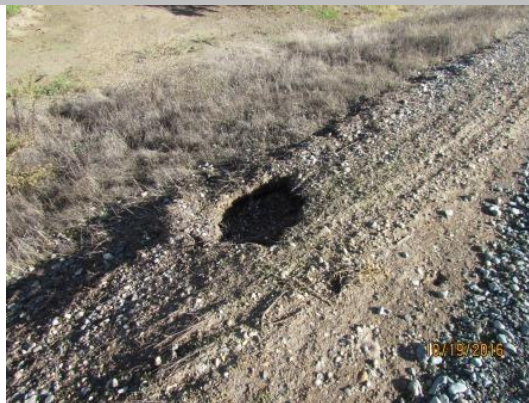
Photo 1 of 1 : SP_2017_RD0817_13_15_20170316_00007.jpg

View of a sink hole were old stump was. This needs to be backfilled and compacted. Fall 2016.

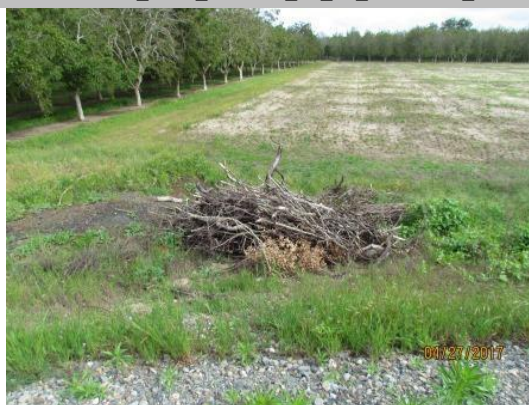
Photo 1 of 1 : SP_2017_RD0817_13_11_20170428_00023.jpg

View of pruning's on the landside levee toe, Spring 2017.

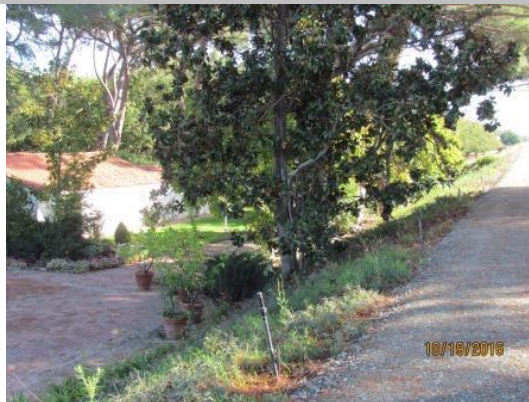
Photo 1 of 1 : SP_2017_RD0817_13_2_20170316_00001.jpg

View of the homeowners landscape vegetation creeping up the landside levee slope, looking upstream. Fall 2016.

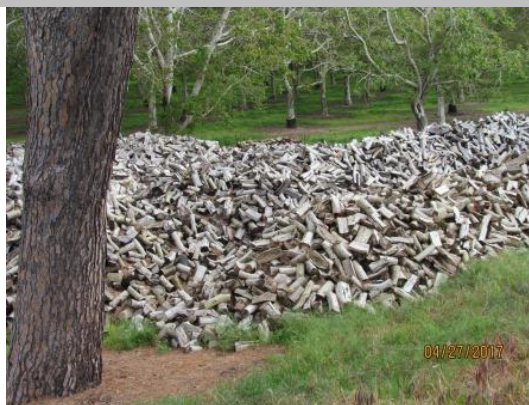
Photo 1 of 1 : SP_2017_RD0817_13_12_20170428_00024.jpg

View of a large pile of firewood that is encroaching on the landside levee toe, Spring 2017.

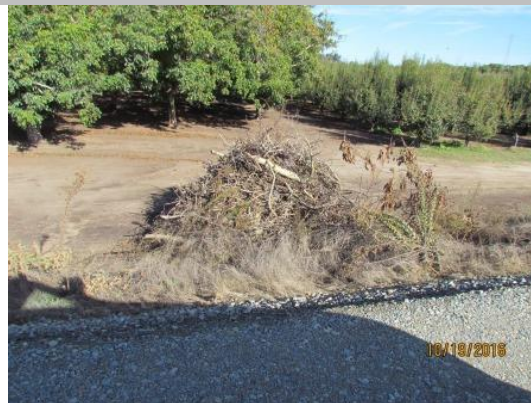
Photo 1 of 1 : SP_2017_RD0817_13_16_20170316_00008.jpg

View of pruning pile at landside levee toe. Fall 2016.

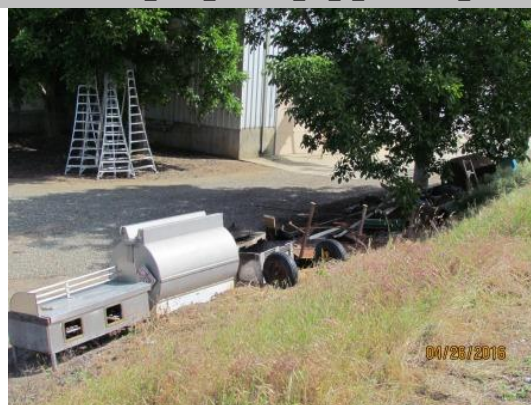
Photo 1 of 1 : SP_2017_RD0817_13_3_20170316_00002.jpg

Photo of equipment encroaching onto the landside toe. This is still the same for Fall 2016 inspection.

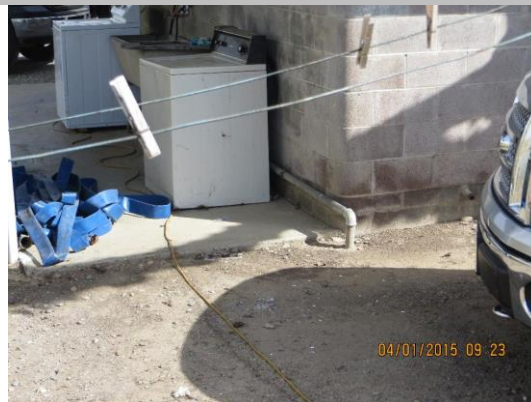
Photo 2 of 3 : UCIP_SP_2017_46182_74560.jpg

Possible source on LS at building corner.

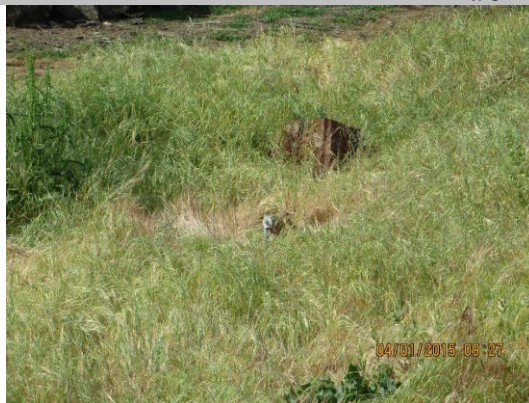
Photo 3 of 3 : UCIP_SP_2017_46182_74561.jpg

Pipe and hose bib visible in tall grass at WS toe.

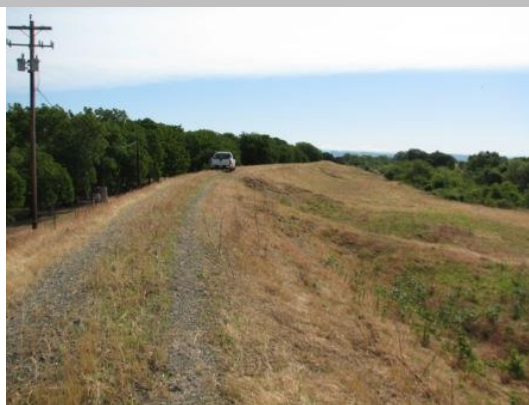
Photo 1 of 2 : SP_2017_RD0817_13_10_20170316_00003.jpg

Levee mile 2.08, this photo shows the slope is less than required, this is the downstream limit of the site, this is the waterside slope.

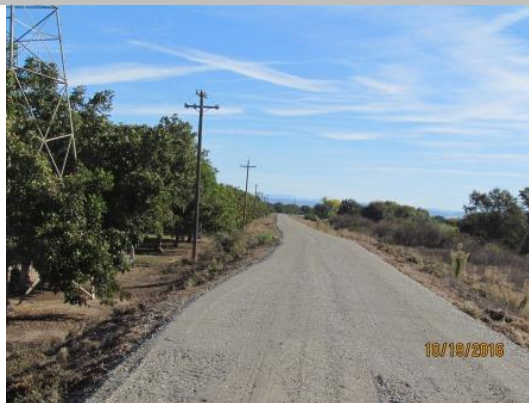
Photo 2 of 2 : SP_2017_RD0817_13_10_20170316_00004.jpg

Photo of approximately the same location of Fall 2016, looking upstream where the waterside slope is steep and less than required.

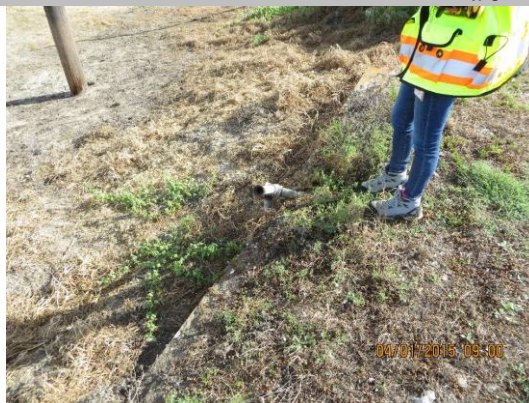
Photo 1 of 3 : UCIP_SP_2017_44105_73586.jpg

Pipe visible on LS shoulder.

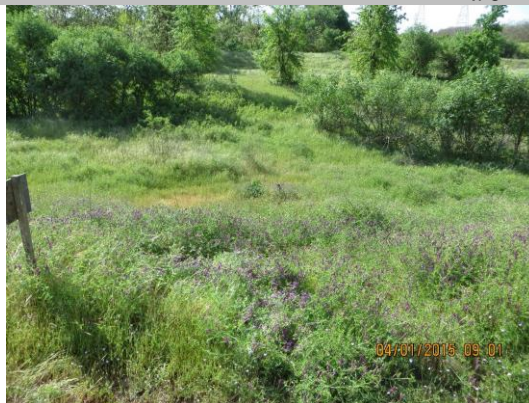
Photo 2 of 3 : UCIP_SP_2017_44105_73585.jpg

WS slope. pipe not visible.

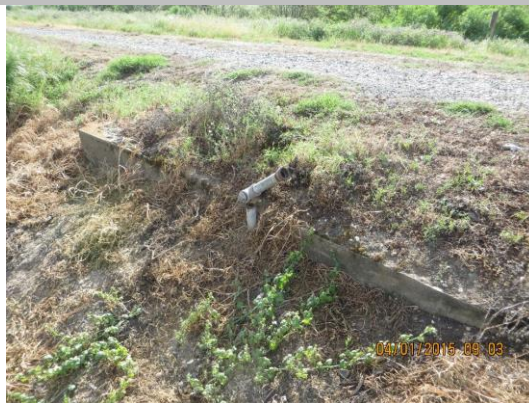
Photo 3 of 3 : UCIP_SP_2017_44105_73584.jpg

Pipe and concrete headwall visible on LS shoulder.

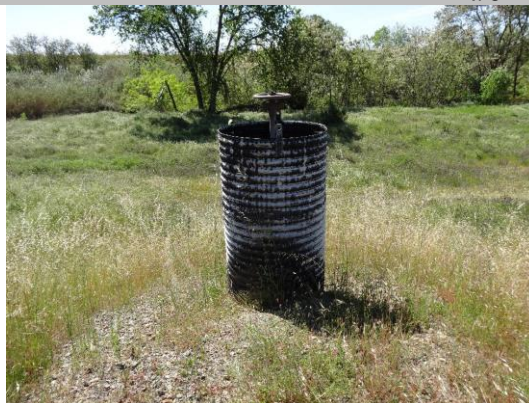
Photo 1 of 3 : UCIP_SP_2017_41160_19922.jpg

WS- CMP riser on levee slope.

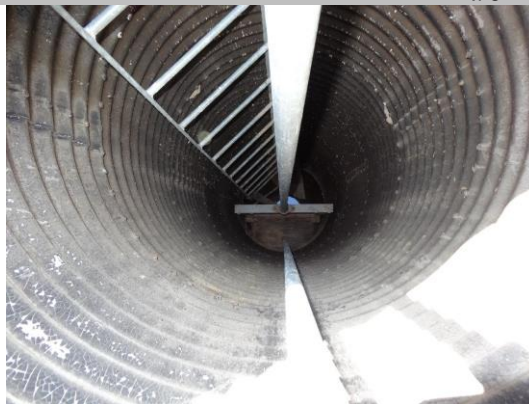
Photo 2 of 3 : UCIP_SP_2017_41160_19921.jpg

WS- inside CMP riser with air vent and slide gate.

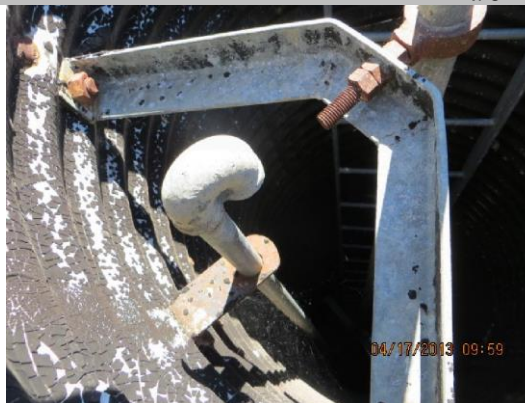
Photo 3 of 3 : UCIP_SP_2017_41160_19920.jpg

WS- CMP riser with air vent and slide gate.

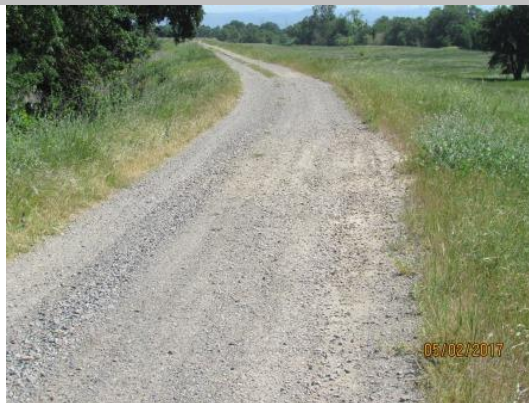
Photo 1 of 1 : SP_2017_RD0817_14_11_20170503_00036.jpg

View looking upstream of typical bare spots on the levee crown that need more aggregate base, Spring 2017.

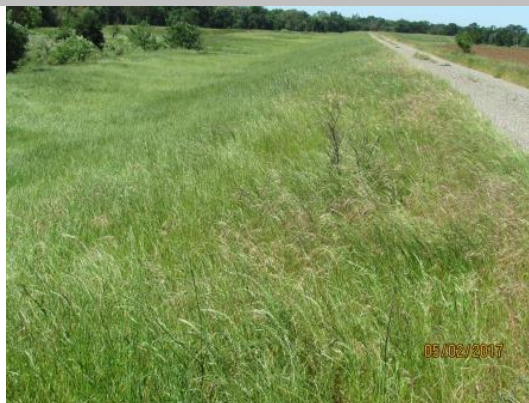
Photo 1 of 2 : SP_2017_RD0817_14_17_20170503_00033.jpg

View of annual grasses that need to be maintained on the waterside looking downstream. Spring 2017.

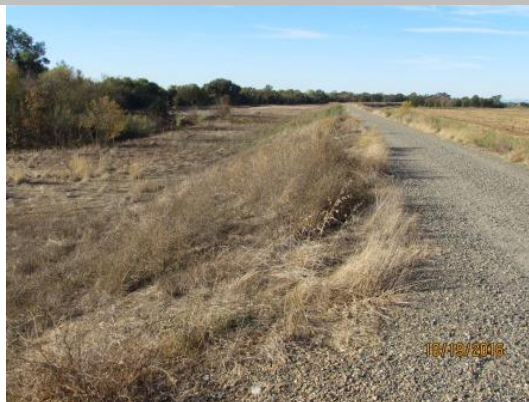
Photo 2 of 2 : SP_2017_RD0817_14_17_20170316_00009.jpg

View of annual grasses that need to be maintained on the waterside looking downstream. Fall 2016.

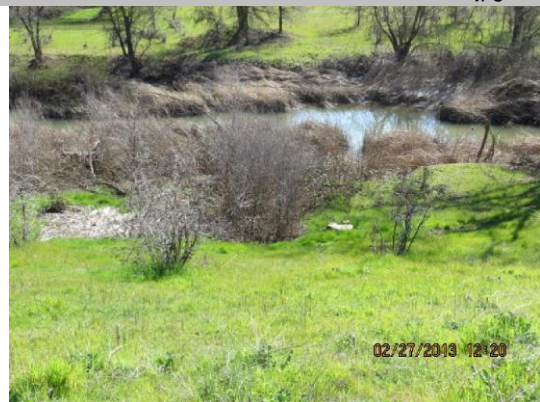
Photo 2 of 3 : UCIP_SP_2017_50231_54270.jpg

Outlet in brush at WS toe.

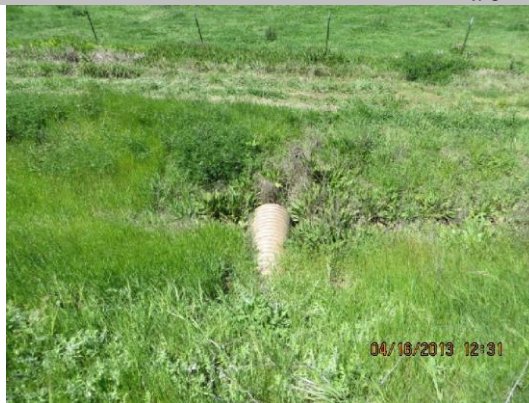
Photo 1 of 3 : UCIP_SP_2017_42686_19927.jpg

LS- overview of CM drainage pipe on toe of the levee.

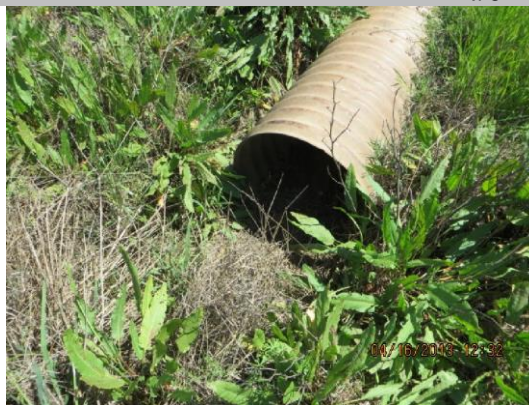
Photo 2 of 3 : UCIP_SP_2017_42686_19926.jpg

LS- CM drainage pipe on toe of the levee.

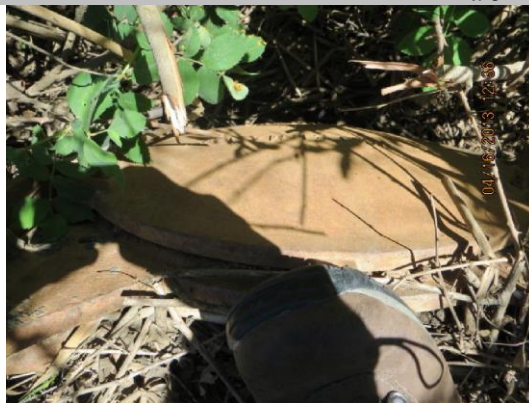
Photo 3 of 3 : UCIP_SP_2017_42686_19928.jpg

WS- flap gate on CMP end on levee toe.

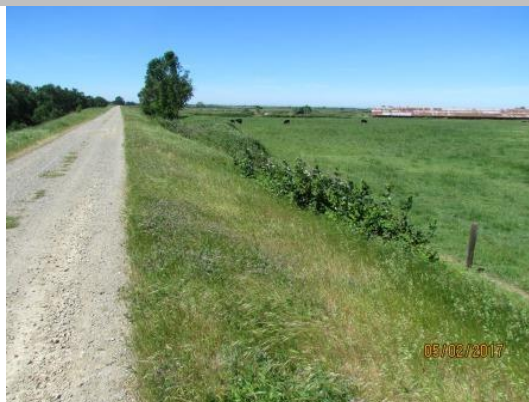
Photo 1 of 1 : SP_2017_RD0817_14_8_20170503_00038.jpg

View of blackberry bushes that are taking over the landside slope looking downstream. Spring 2017.

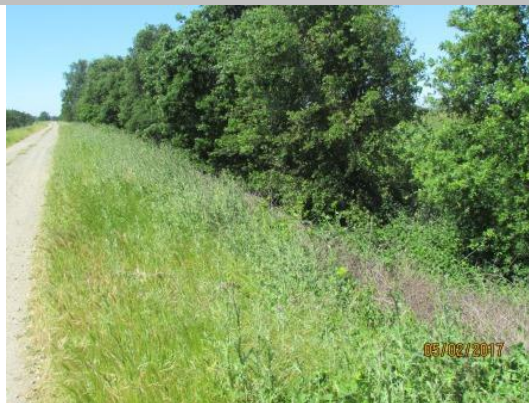
Photo 1 of 2 : SP_2017_RD0817_14_4_20170503_00037.jpg

View looking downstream of trees that need limbs to be trimmed for access and visibility, Spring 2017.

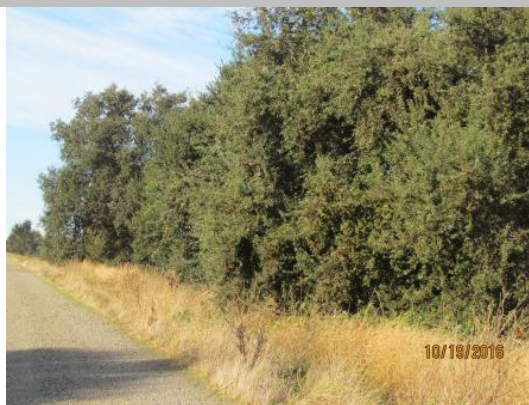
Photo 2 of 2 : SP_2017_RD0817_14_4_20170316_00001.jpg

View of trees that need limbs to be trimmed for access and visibility, Fall 2016.

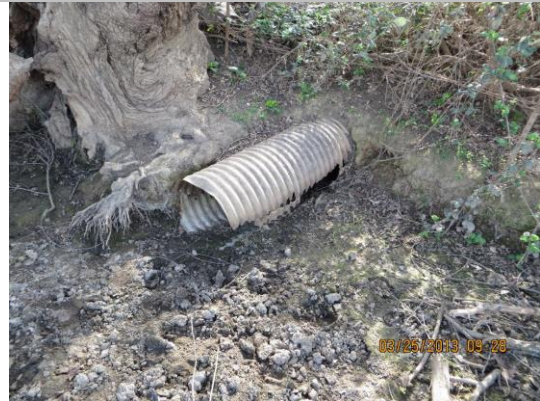
Photo 1 of 3 : UCIP_SP_2017_50230_53849.jpg

Pipe on LS toe corroded through.

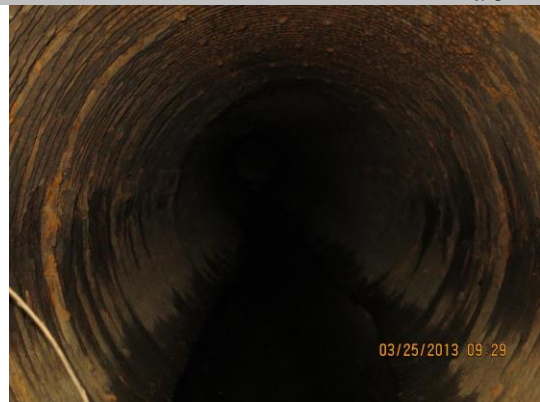
Photo 2 of 3 : UCIP_SP_2017_50230_53848.jpg

Pipe Heavily corroded throughout

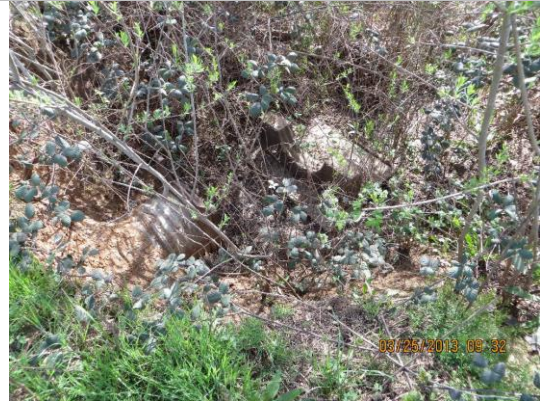
Photo 3 of 3 : UCIP_SP_2017_50230_53847.jpg

Pipe no longer mounted to headwall at WS toe.

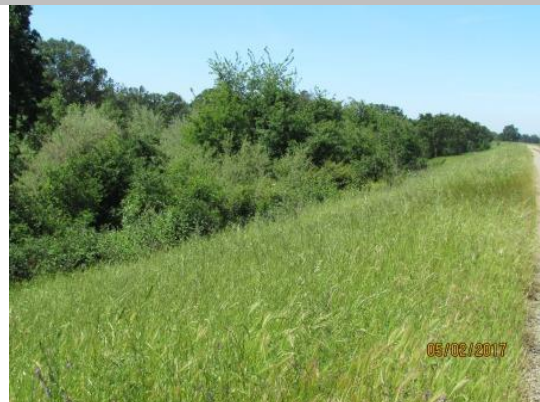
Photo 1 of 1 : SP_2017_RD0817_14_20_20170503_00039.jpg

View looking downstream of trees and bushes that block the view of the levee slope, Spring 2017.

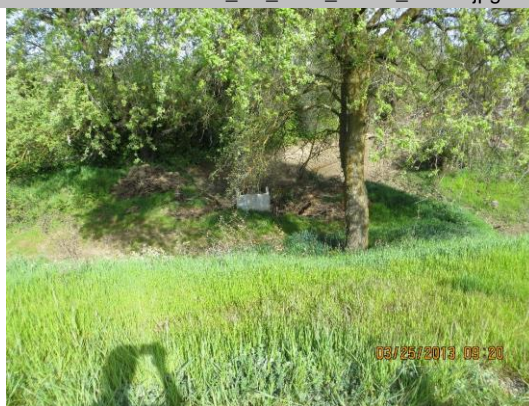
Photo 3 of 3 : UCIP_SP_2017_50232_53852.jpg

Improvised concrete inlet on LS toe.

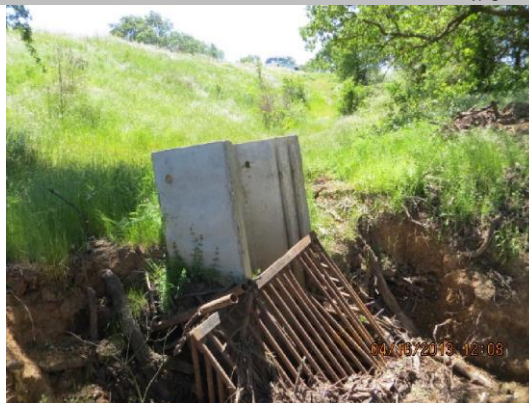
Photo 3 of 3 : UCIP_SP_2017_41163_19940.jpg

LS- half box concrete outlet structure with trash rack.

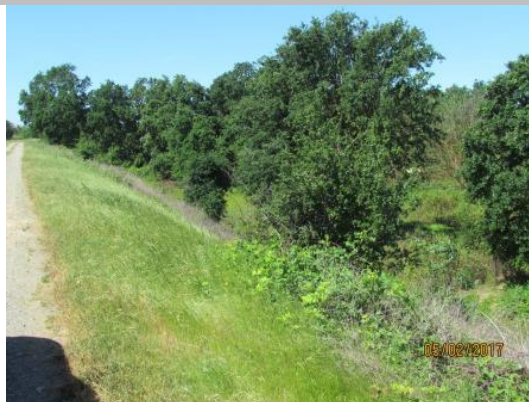
Photo 1 of 2 : SP_2017_RD0817_14_19_20170503_00034.jpg

View of trees that need limbs to be trimmed for access and visibility, Spring 2017.

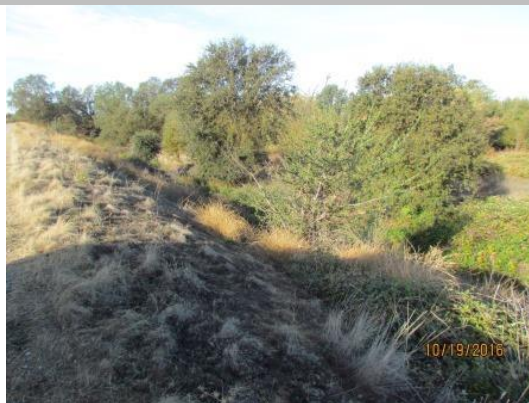
Photo 2 of 2 : SP_2017_RD0817_14_19_20170316_00010.jpg

View of trees that need limbs to be trimmed for access and visibility, Fall 2016.

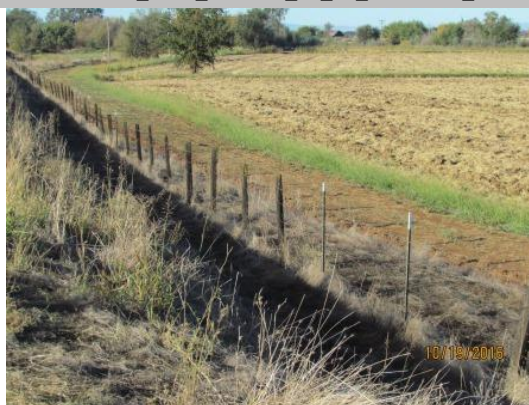
Photo 1 of 1 : SP_2017_RD0817_14_15_20170316_00007.jpg

View of fence at landside toe looking downstream.

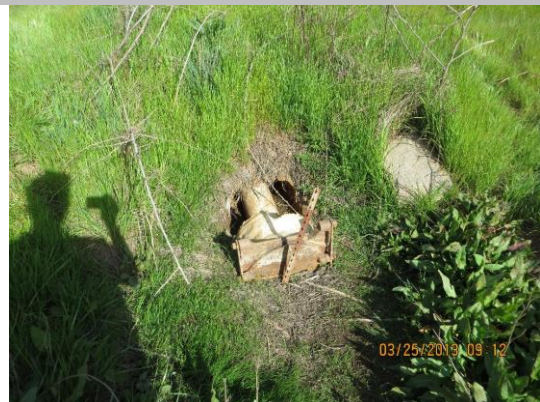
Photo 2 of 3 : UCIP_SP_2017_50234_53856.jpg

Pipe cut behind flap gate on WS toe with 8-inch PVC.

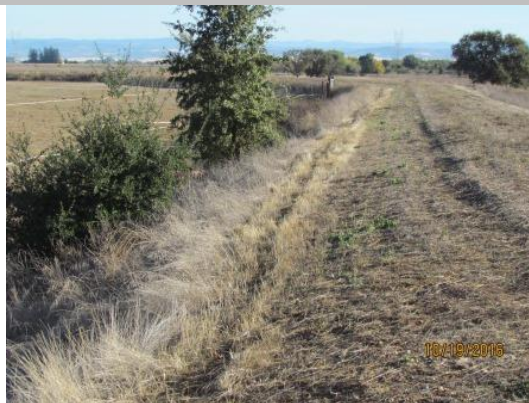
Photo 1 of 1 : SP_2017_RD0817_14_12_20170316_00003.jpg

View of annual grasses on the landside looking upstream.

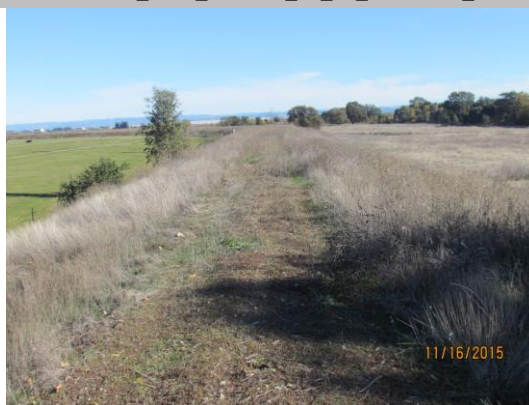
Photo 1 of 2 : SP_2017_RD0817_14_14_20170316_00005.jpg

View of the vegetation on the crown of the levee looking upstream.

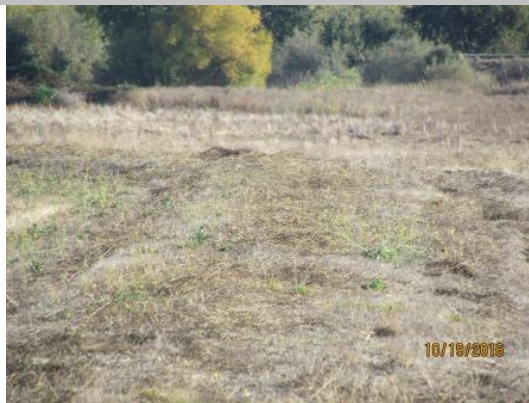
Photo 2 of 2 : SP_2017_RD0817_14_14_20170316_00006.jpg

View of the vegetation on the crown of the levee looking upstream. Fall 2016.

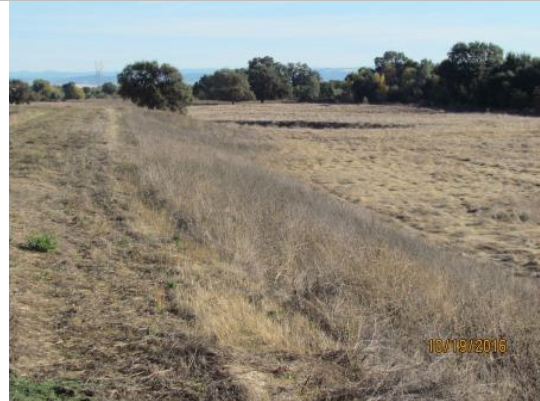
Photo 1 of 1 : SP_2017_RD0817_14_13_20170316_00004.jpg

Fall 2016 View of waterside looking upstream.

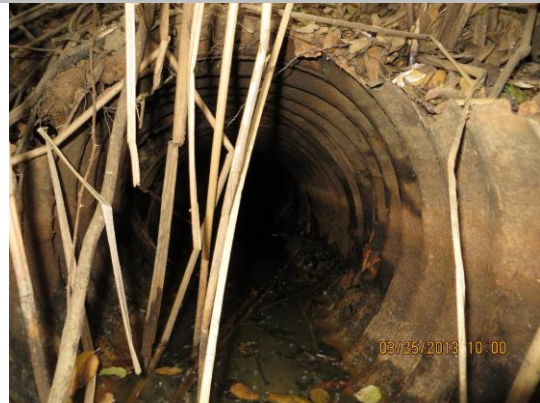
Photo 1 of 3 : UCIP_SP_2017_50235_53859.jpg

Pipe at inlet on LS toe.

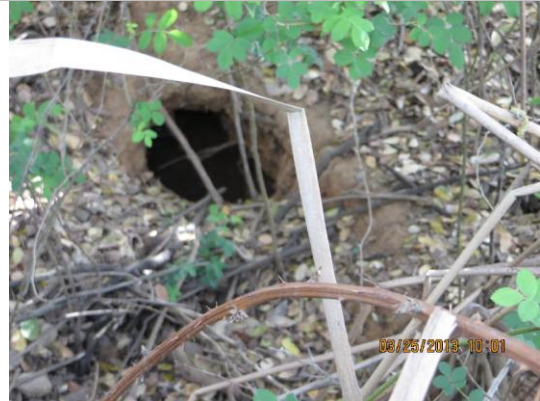
Photo 2 of 3 : UCIP_SP_2017_50235_53858.jpg

Sinkhole or animal burrow over pipe on LS toe.

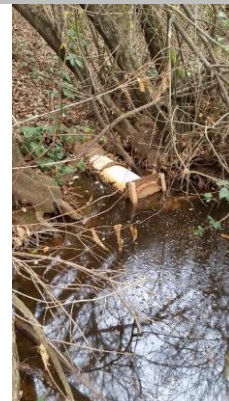
Photo 3 of 3 : UCIP_SP_2017_50235_74804.jpg

WS drainage outlet with flap gate. Steel pipe is sleeved within heavily rusted CM pipe near daylight to embankment
